Date: October 8, 2018

Subject: Post-Repair Foundation Repair Evaluation
Pier and Beam Foundation
3505 Royal Ln, Dallas, TX 75229

Crosstown Land Development Services
Texas Engineering Firm (F-15944)

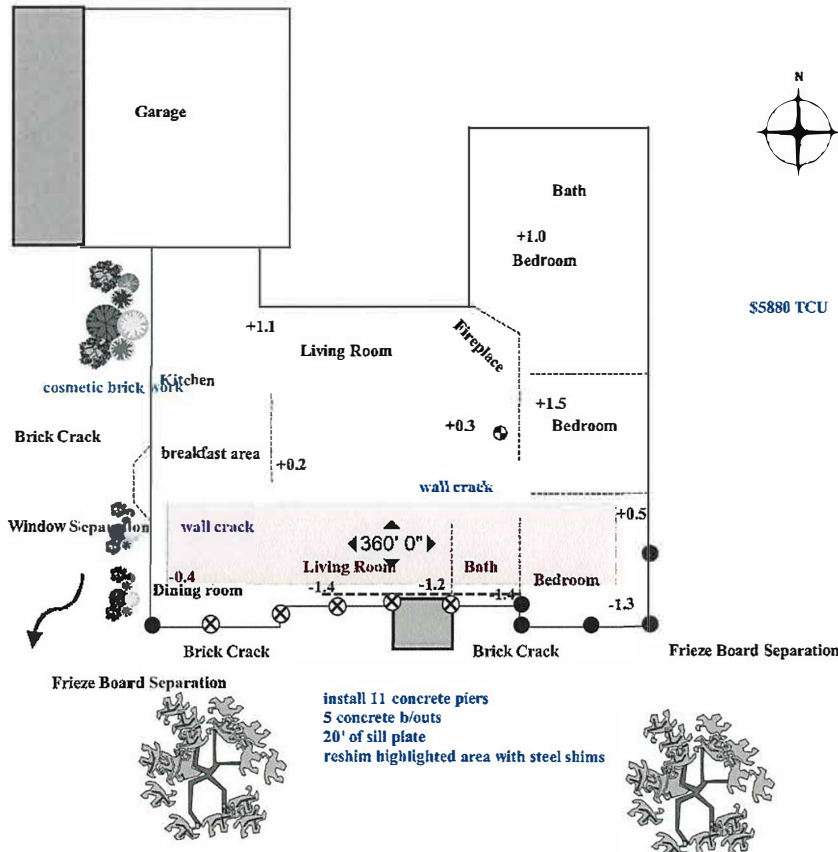
Based on our observations of the structure and a review of the limited repair plan provided by the contractor, the structure has experienced general foundation movement over the life of the structure, resulting in differential movement within the pier and beam structure. Brick cracks, drywall cracks, ceiling cracks, foundation cracks, window separations, frieze board separations, and trim separations were observed.

- Installed 11 total pilings (6 exterior, 5 breakouts)
- Installed 20 LF of sill plate.
- Reset/re-shimmed the entire front beam with steel to improve leveling.
